TITLE: HEAT PIPE DEVELOPMENT STATUS

AUTHOR(S): Michael A. Merrigan

SUBMITTED TO First SP-100 Program Integration Meeting
Radisson-Ferncroft Hotel
Danvers, MA
June 13-15, 1984

HEAT PIPE DEVELOPMENT STATUS

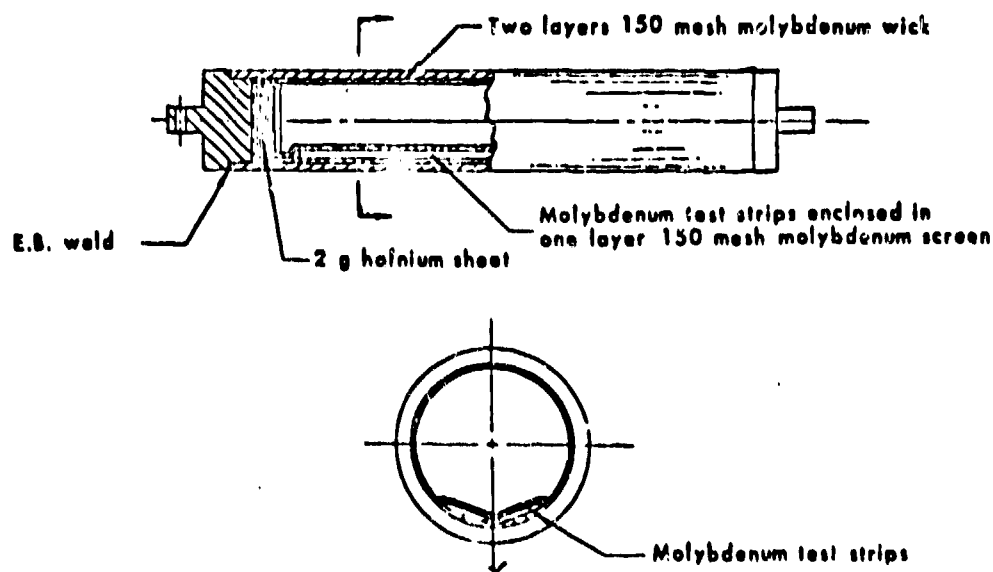
Fig. 1. Mo/Li heat pipe corrosion specimen.

During disassembly, the heat pipe was found to be mostly empty of the lithium, so post-test chemical analysis of the lithium working fluid could not be performed. Seven metallographic samples were taken from various regions of the heat pipe. One of them included the failure holes. After polishing, the larger of the two holes was exposed in cross-section. Electron microprobe analysis indicated the presence of nickel in the area adjacent to the hole. Because there is a peritectic in the Mo-Ni binary phase system with a melting temperature of 1635 K, it was concluded that the observed structure was the remnant of a nickel-rich liquid, while areas of lower nickel concentration corresponded to molybdenum-rich Mo-Ni solid solution. Ion microprobe analysis indicated that lithium and oxygen were also present in the region.

Grain boundary penetration was observed in the vicinity of the hole on the inside of the heat pipe along with an occasional string of grain boundary precipitates near the inside surface of the tube. A surface layer found on the lower portion of the evaporator inner surface was analyzed with the electron microprobe, and it was found to be rich in hafnium. Hafnium was also found to have diffused 10 to 20 μm into the heat pipe wall, and in some areas near the inside of the tube wall, hafnium-rich grain boundary precipitates were found at greater depths. No remnant of the hafnium getter foils was found in their original

A possible mechanism for the failure of this heat pipe is indicated by the analyses. Stainless steel component impurities, Fe, Ni, and Cr were concentrated in the evaporator of the heat pipe during operation, until the nickel concentration reached a level in excess of 1.8 at.% locally and a liquid phase peritectic formed which eventually penetrated the heat pipe wall. Because other elements, such as Fe, Cr, Si and O, were found in the vicinity of the hole, the actual failure mechanism is probably more complex than this simple model, however as the lithium in this test had been processed and stored in stainless steel containers and not distilled into the heat pipe, it is reasonable to presume it was contaminated with nickel due to the high solubility of nickel in lithium.
